# Experimental impact damage tolerance evaluation of thick composite structures

Low- and high-velocity impact followed by compression-after-impact

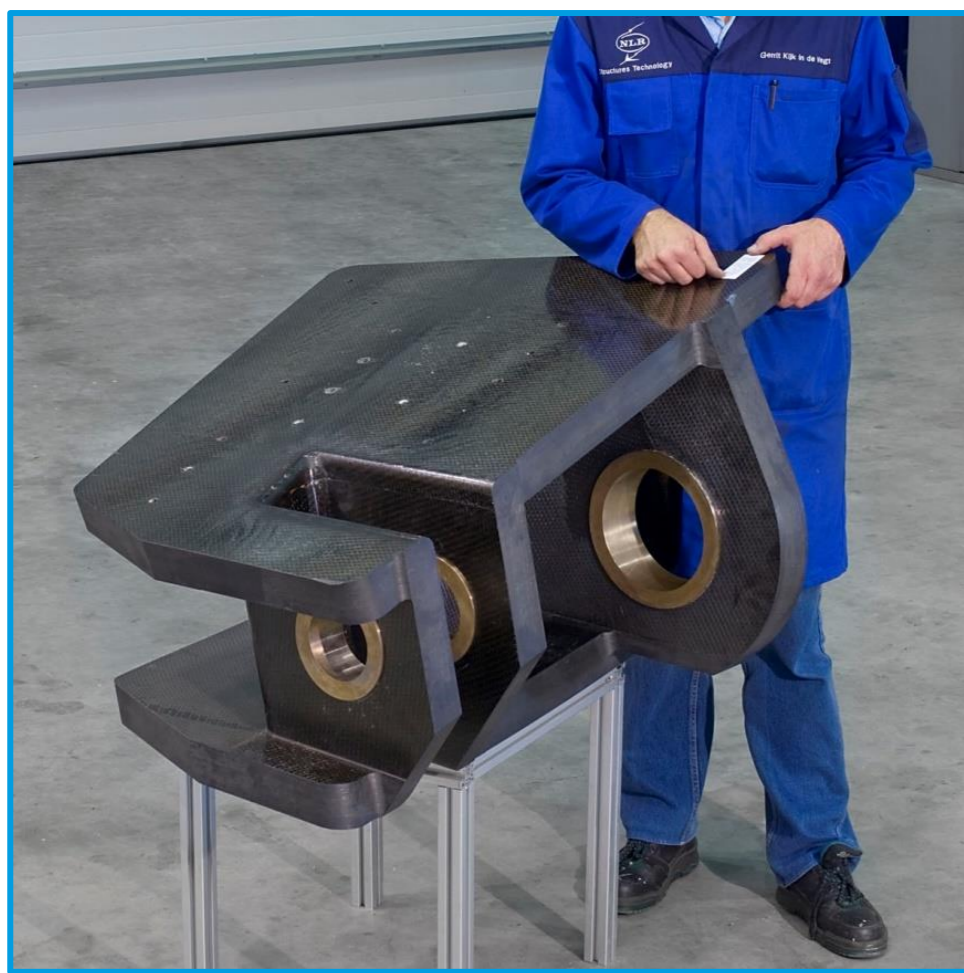
Gear rib of the Affordable Low Cost Aircraft Structures (ALCAS) airliner wing [1].

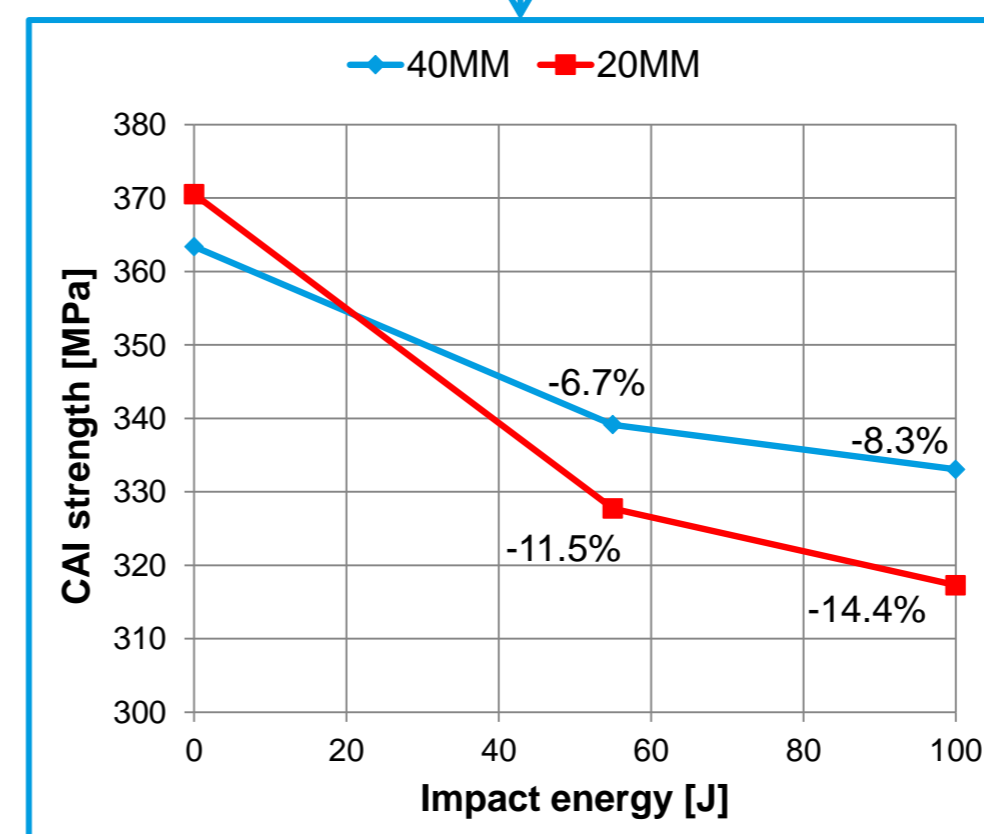
Large-mass drop-tower

**Results:** CAI strength as function of thickness and impact energy

- ✓ The experimental data is used for the validation of numerical models
- ✓ Anomalies for small-mass impact, compared to large-mass, are that...
  - ...the delaminated area is significantly higher for 20mm specimens (+112% @ 100J)
  - ...the layup has a considerable effect on the dent depth (+60% for the QI layup @ 55J)
- ✓ Residual CAI strengths show a relatively small effect of impact damage
